SKF Gulf

Bearing Root Cause Failure Analysis

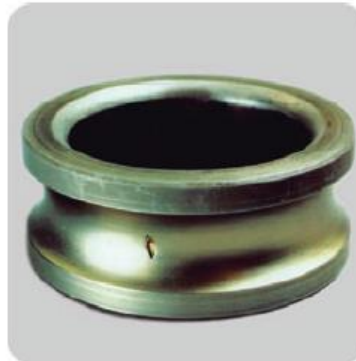
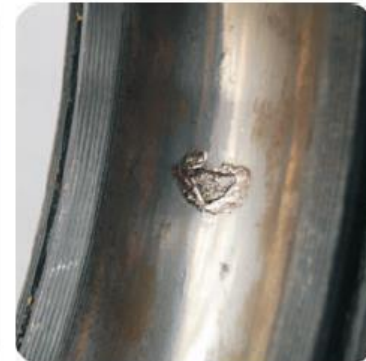
Subsurface initiated fatigue

Spalling of particles as a result of microcracks below the raceway surface

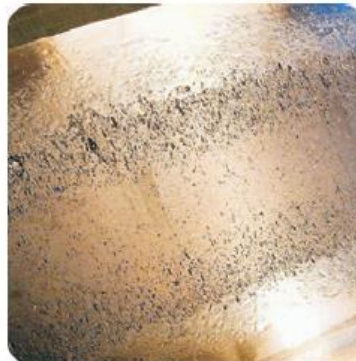
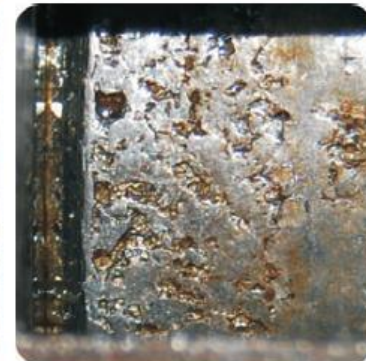
Surface initiated fatigue

Distress of the surface. Failure of the rolling contact metal surface asperities due to inadequate lubrication

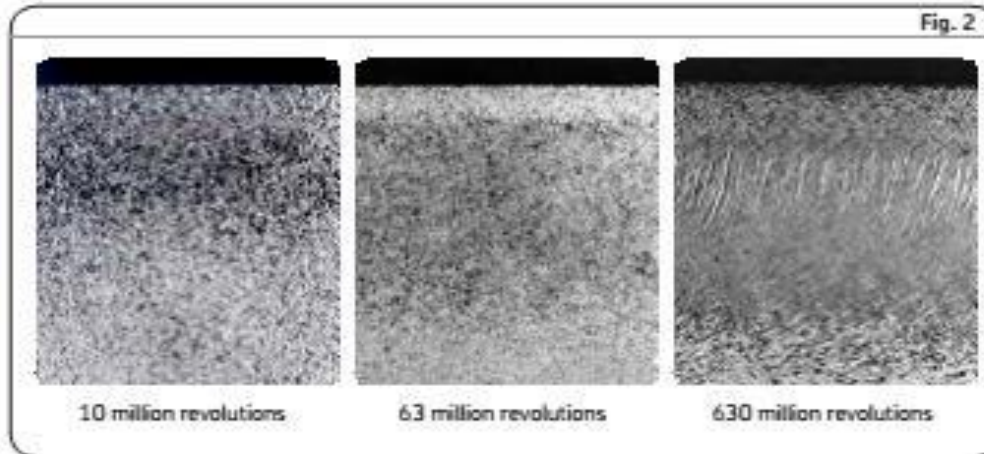
Changes in structure beneath the raceway surface over time (highly stressed, well lubricated small deep groove ball bearing)

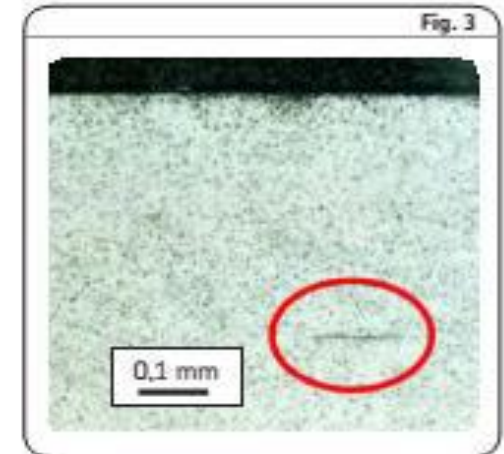
Crack development beneath the raceway surface (~ 0,3 mm)

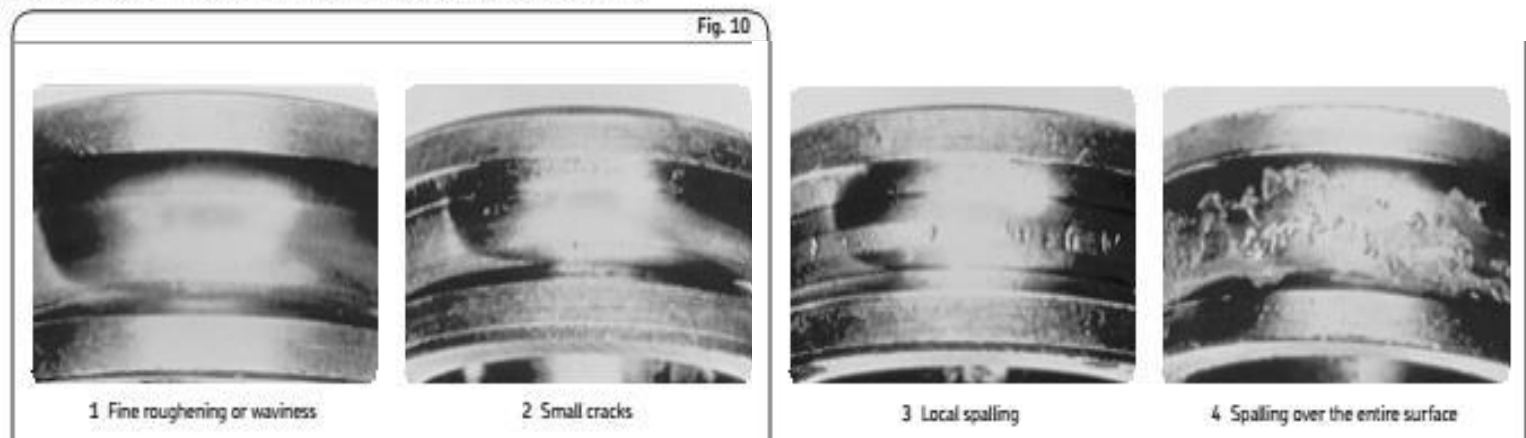
Progress of surface initiated fatigue on the inner ring of a deep groove ball bearing

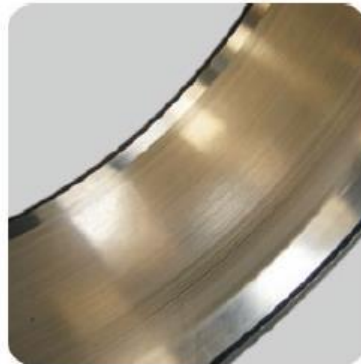
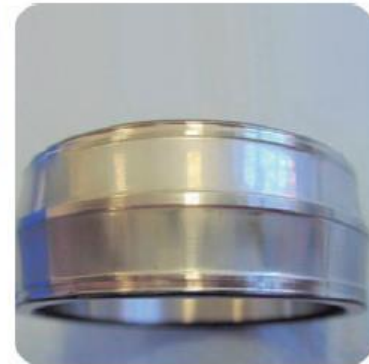
Abrasive wear

The result of inadequate lubrication or the ingress of contaminants

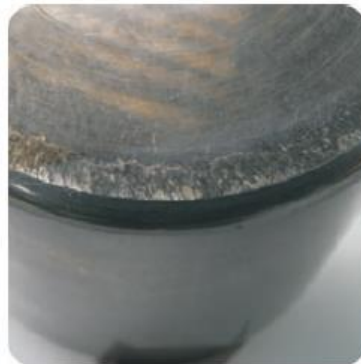
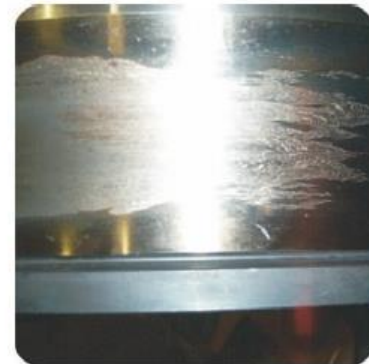
Adhesive wear

Material transfer from one surface to another as a result of frictional heat

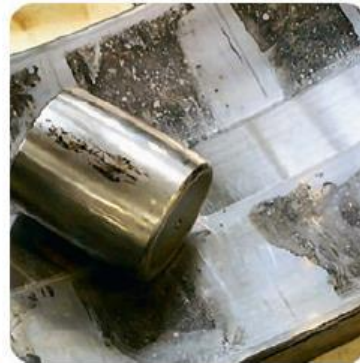
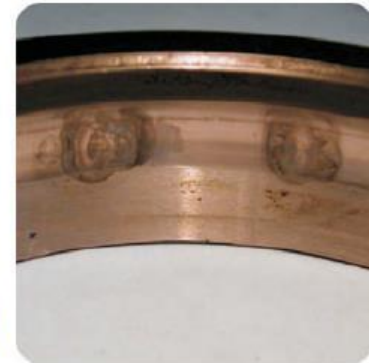
Moisture corrosion

Oxidation of the surfaces in the presence of moisture

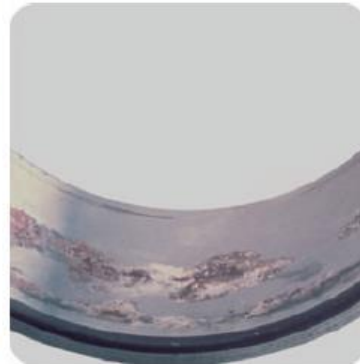
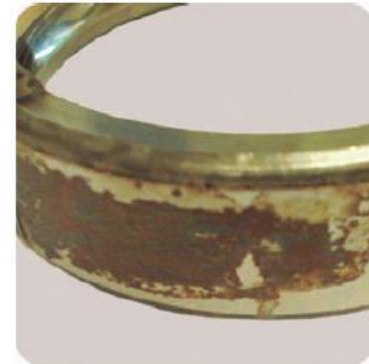
Fretting corrosion

The oxidation and wear of surface asperities under oscillating micromovement between mating surfaces

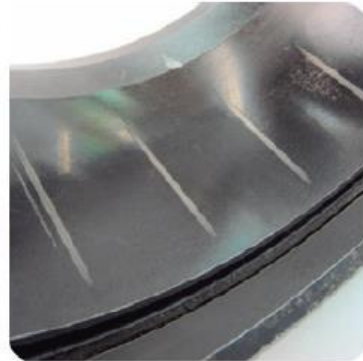
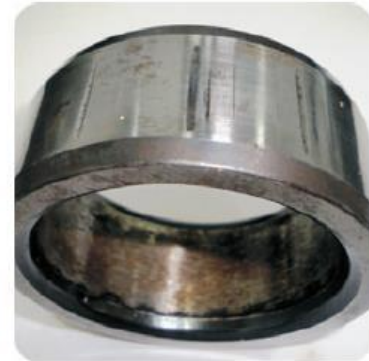
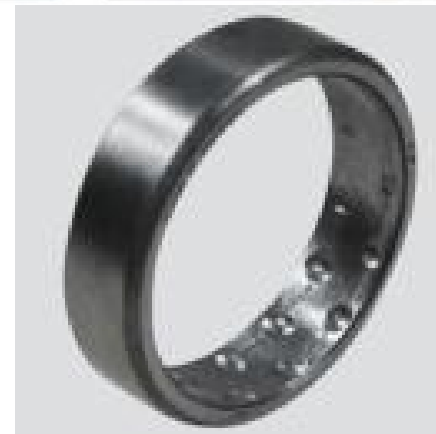
False brinelling

Shallow depressions in raceway/rolling element contact caused by cyclic vibrations on a non rotating bearing

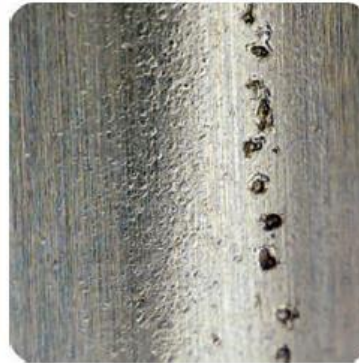
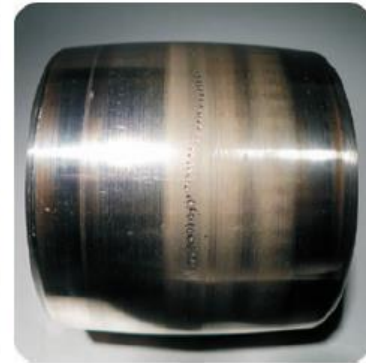
Excessive voltage

Sparking and localized heating from current passage in the contact area because of ineffective insulation

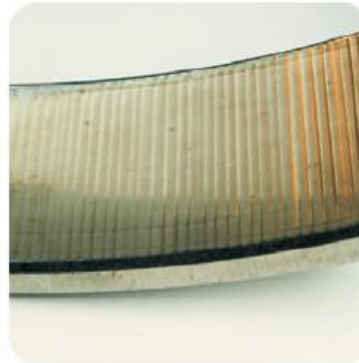
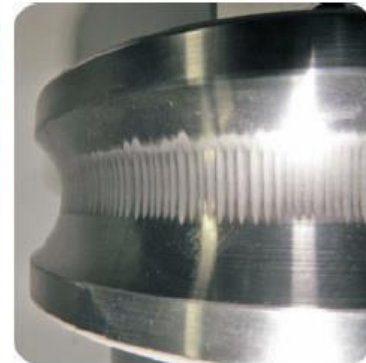
Current leakage

The generation of shallow craters from (low) current passage. They develop over time into flutes

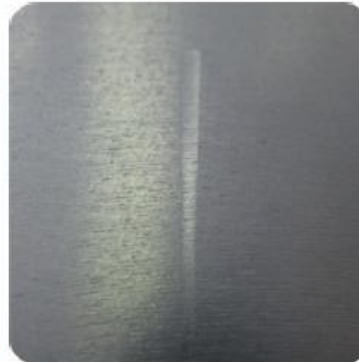
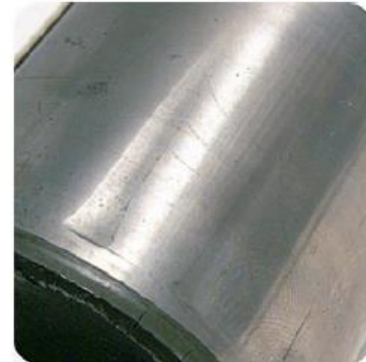
Overload

Permanent deformation caused by static or shock overloads (true brinelling)

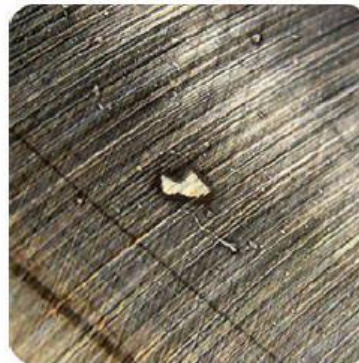
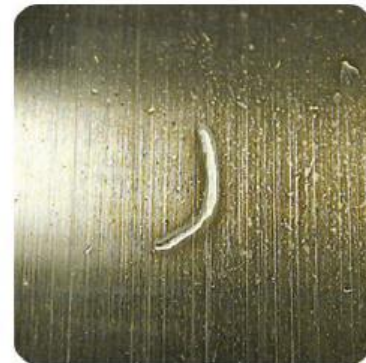
Indentation from debris

Dents as a result of particles that are over-rolled in the raceway/rolling element contact areas

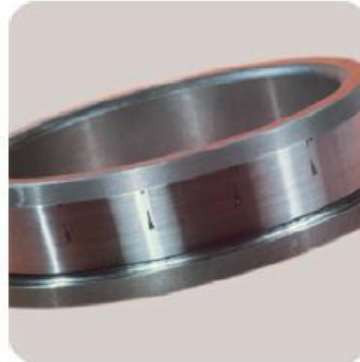
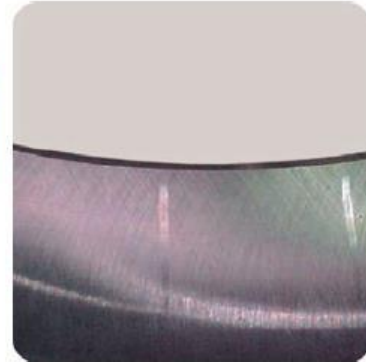
Indentation from handling

Bearing surfaces that are dented or gouged by hard, sharp objects

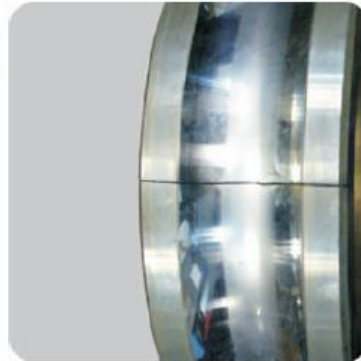
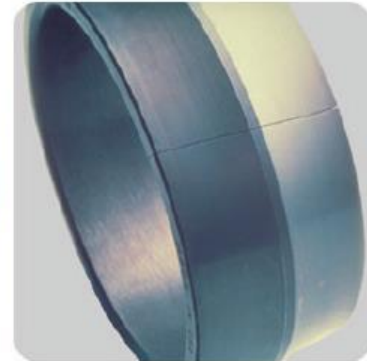
Forced fracture

A fracture resulting from a stress concentration in excess of the material's tensile strength

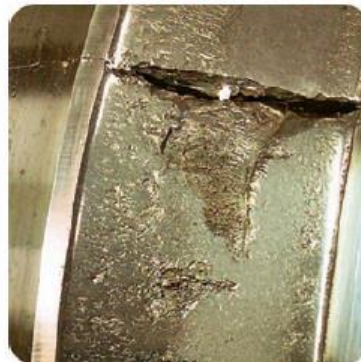
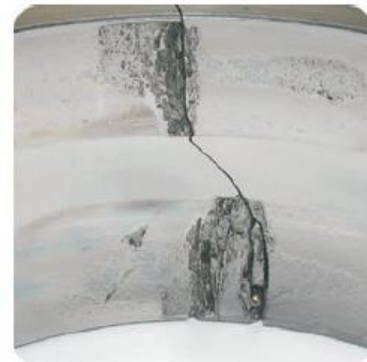
Fatigue fracture

A fracture resulting from frequently exceeding the fatigue strength limit of the material

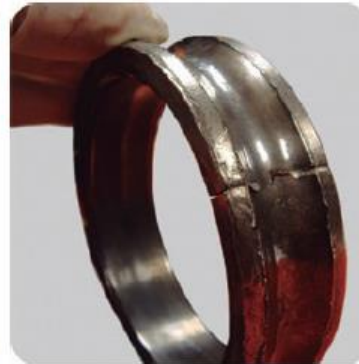
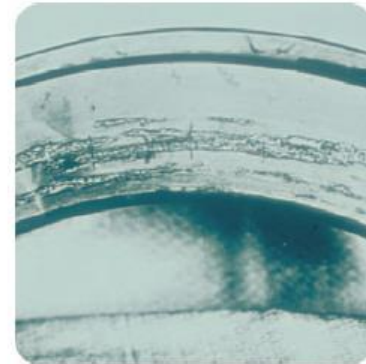
Thermal cracking

Cracks that are generated by high frictional heating. They usually occur perpendicular to the direction of the sliding motion.

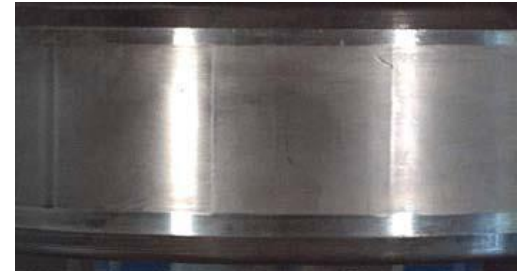
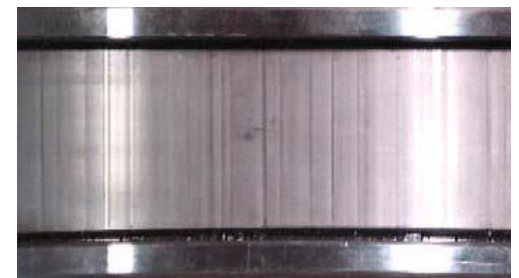
After only one month of operation there was severe damage to the cylindrical roller bearing.

Inner ring: There was heavy wear on the raceway. The wear was irregular; some flats were observed. The raceway was dull and grey in colour.

Outer ring: There was heavy wear on the raceway (load zone). The wear was irregular. Marks similar to those caused by vibration (washboarding) were visible. The raceway was dull and grey in colour. The insulation coating on the outside surfaces was intact.

The raceway surface showed microcraters that were the result of a damaging electrical current passing through the bearing (current leakage). This led to washboarding. After that (and continuously) a large amount of material had worn off, and had led to the strange pattern on the raceways of the inner and outer rings.

The failure mode is clearly current leakage erosion.

The inspection showed that during one of the motor repairs, the grounding (earth) cable was disconnected and not reconnected. Once the grounding cable was reconnected and another set of insulated bearings was installed, no further problems were reported.

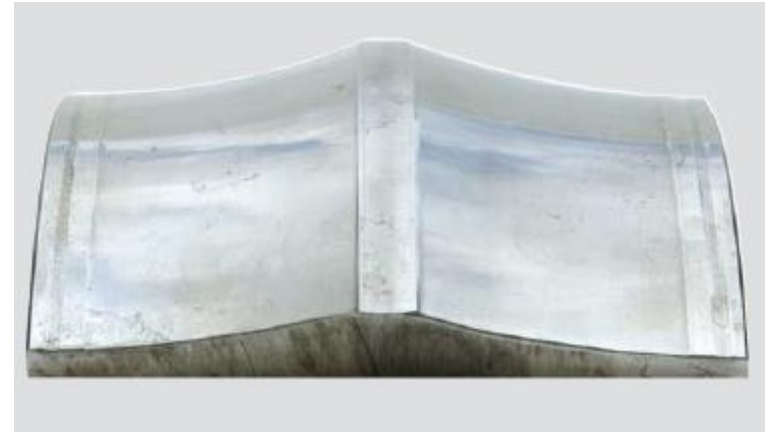
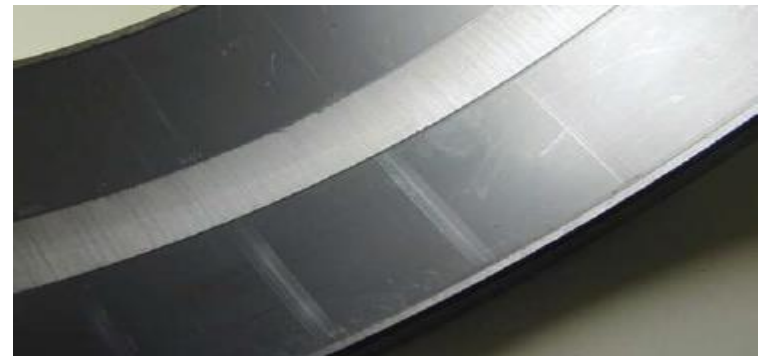
The bore showed no signs of fretting corrosion and the side faces were undamaged. The raceways showed severe abrasive wear. On both raceways, the cages had cut a groove at the edge of the raceway, indicating that the cages were making contact with the raceways. The raceways were dull and grey in colour.

The raceways showed heavy abrasive wear, and were dull and grey in colour. There were also transverse smearing marks (at roller pitch) from dismounting. Severe fretting corrosion was visible on the outside surface, which was the result of ring creep movements under heavy load and uneven ring support.

There was a huge amount of abrasive wear in the bearing. The cage pocket clearance had increased substantially, making the cage drop and cut a groove at the edge of the raceway. Clearly, there was a problem with lubrication resulting from clay that entered the bearing cavity.

The failure mode is clearly abrasive wear.

Improve the sealing arrangement to protect the bearing. This can be done by:

- relubricating daily
- using sealed SKF Explorer spherical roller bearings
- using a labyrinth seal that has a relubrication feature
- replacing the current sealing solution with SKF taconite seals
- installing a continuous relubricator

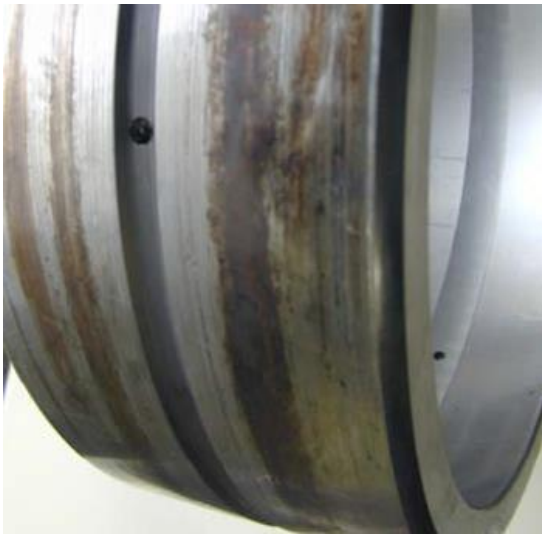
Outer ring: Fretting corrosion
on the outside surface

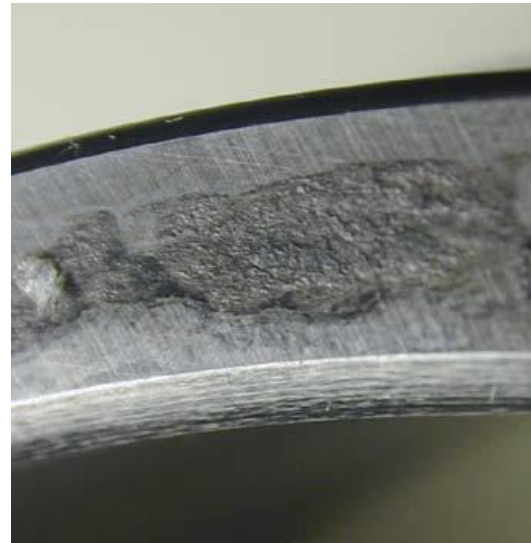
Outer ring: Fretting corrosion
on the side face

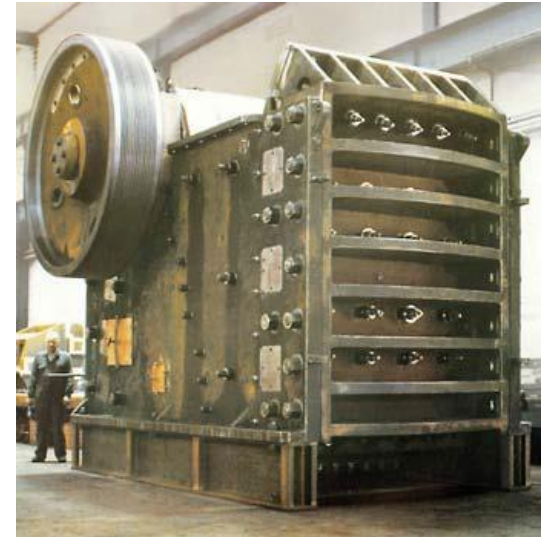
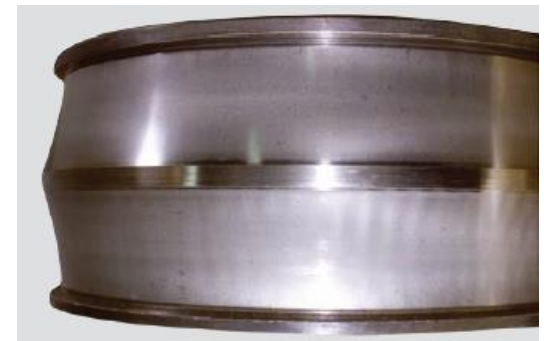
Inner ring: There was heavy abrasive wear on the raceways. No other marks were visible.

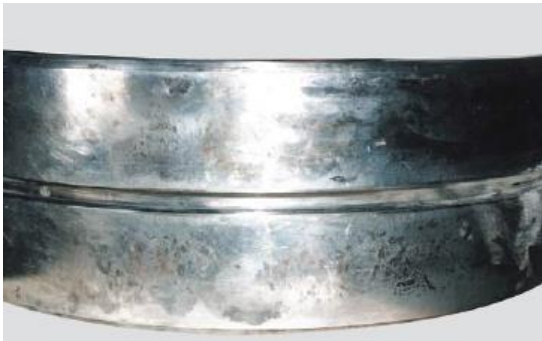
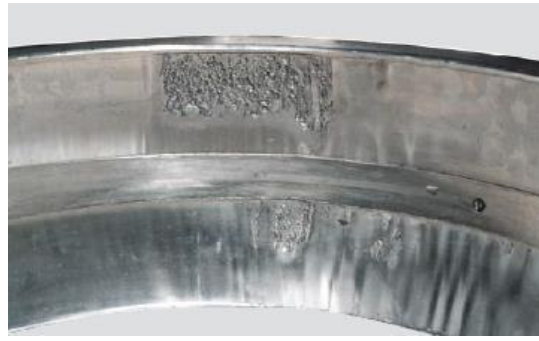
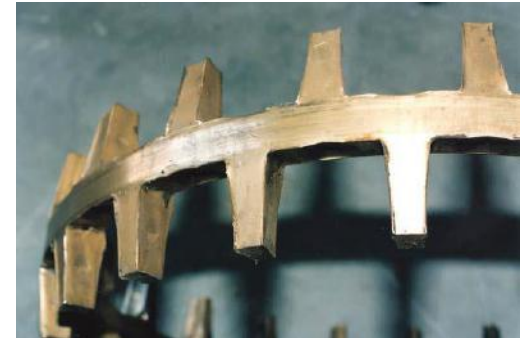
There was heavy spalling on the raceways in a small area of the load zone. There were heavy vibration marks over a large part of the load zone. There was heavy fretting corrosion on the outside surface corresponding to the load zone.

The cage pockets exhibited heavy and irregular wear.

The cause of the failure appeared to be the fretting corrosion from a damaged outer ring seat.
